Caomhnú Árann EIP Project:

LLOC5013: REHABILITATION OF COASTAL HABITATS THROUGH GRAZING MANAGEMENT

Final Report

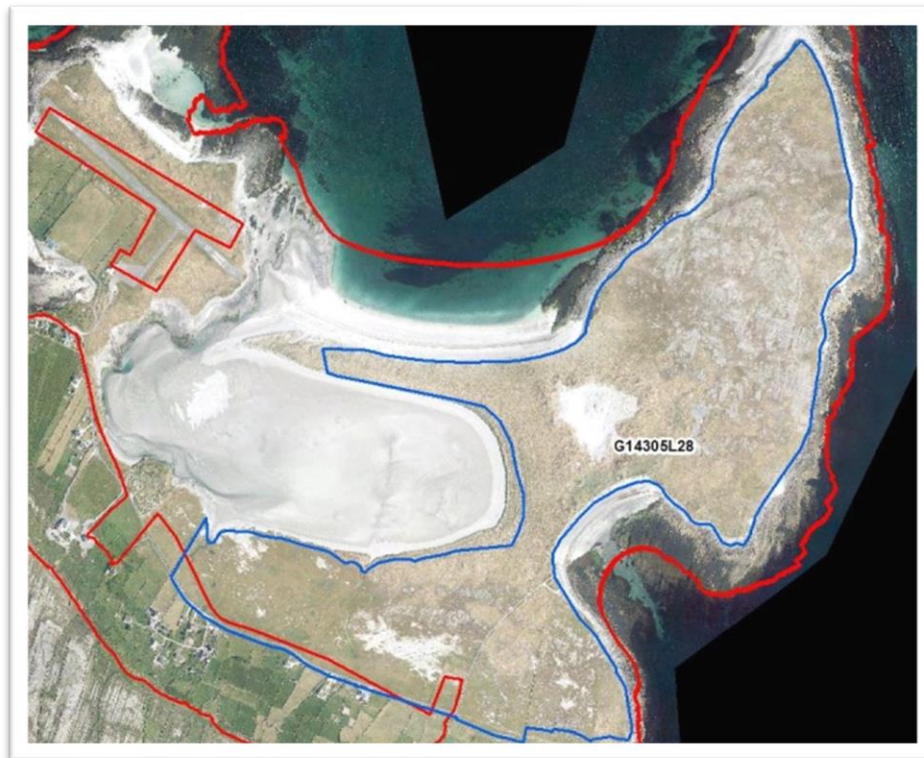
Fig.1 The area of the proposed site outlined in Blue with the SAC designation in red.

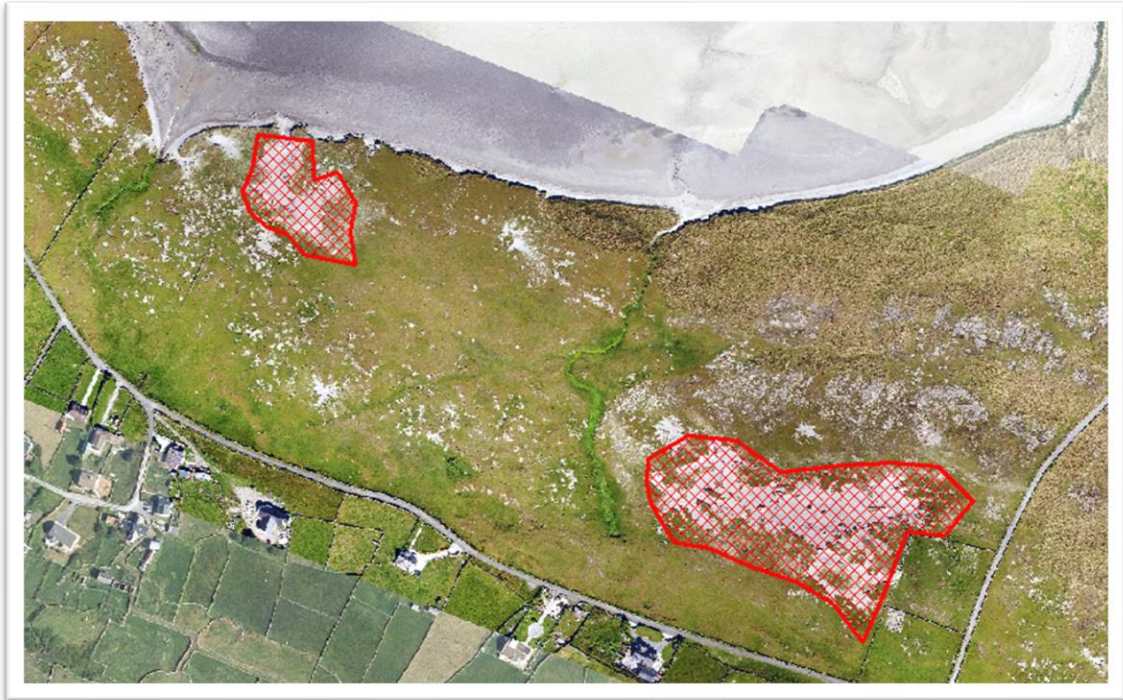
Parts of the Machair are severely eroded and were getting progressively worse over the years as the rabbit population continued to grow unchecked and to graze the site heavily, throughout the year. The western and south eastern section of the Machair had some of the most eroded Machair within the site (Fig.2). Large bare sand areas occur with small islands of vegetation up to 1m in height, which are evidence of the scale of the erosion event that has taken place (Fig.3). Elsewhere smaller bare patches are common as well as areas with the thinnest covering of vegetation (Fig. 2).

Fig.2 Severely eroded areas of Machair where over grazing and burrowing by rabbits has produced large areas of bare sand which are developing in to blow-outs

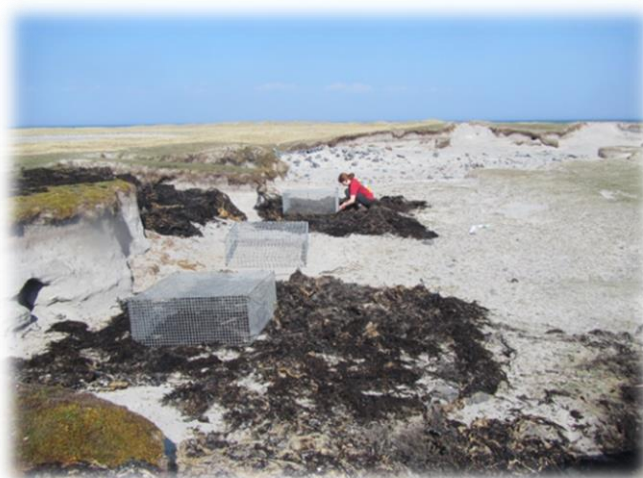
Fig.14 Enclosure cages to prevent rabbit access with different treatments

To encourage stabilisation of eroding substrate storm deposited seaweed was applied to the bare sand areas within the trial plot. The seaweed increases the water retaining capacity of the substrate and increases the organic content thereby facilitating revegetation. In some areas wild flower seed collected from a nearby Machair site on Inis Meáin was also be applied to the test plots to encourage the establishment of vegetation cover to the site. A test site was also trialled to test the effectiveness of planting plugs of Kidney Vetch (*Anthyllis vulneraria*), Birdsfoot (*Lotus corniculatus*) and Ladies Bedstraw (*Galium verum*), grown from seed collected on the island. Enclosure cages (Fig.14) were established on different areas which prevented rabbit access and allowed the vegetation recovery to be monitored (Fig.15).

The result of this work was successful if rabbit grazing could be excluded, which good strike rates and cover from the treated areas although the planting of plugs was less successful, likely due to the sand blowing over the area increase planting depth. Electric fencing (Fig.16) was also tried as a way to exclude rabbits from the re-vegetating areas, but a trial area proved unsuccessful with rabbits continuously breaching the fence. Due to the cost of fencing on a large scale this was rejected as a suitable measure.

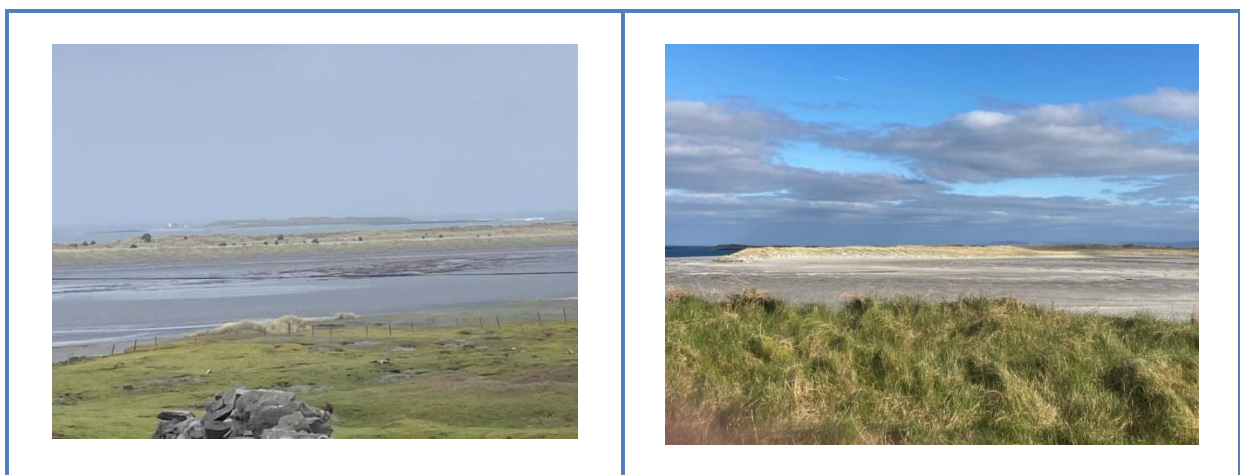
The spread of invasive non-native shrubs within the Machair and dune system, *Olearia traversii* (Daisy bush or Ake ake) had naturalised in the dunes, from dumping of hedge clippings as well as possible natural dispersal mechanisms. *Olearia traversii* is a species of flowering plant in the family Asteraceae. It is endemic to the Chatham Islands of New Zealand. It is grown in other areas with mild oceanic climates such as Scotland. The shrub can become naturalised, reproducing by seed, and can propagate from semi-hard wood cuttings. It is a common component of the hedges within the GAA pitch and the adjacent houses close to the Trá Mór Machair. This species is not listed on the National Biodiversity Data Centre list of invasive species of either High or Medium impact but has continued to spread on the Machair complex.

Fig.18 Before and after photos of the site to show removal of the *Olearia traversii*.

After consulting with the farming stakeholders and members of the public living close to the Machair, the scrub was removed from the Machair complex (see Fig.18 for before and photos of the site). This was done through pulling, cutting with follow up stump treatment.

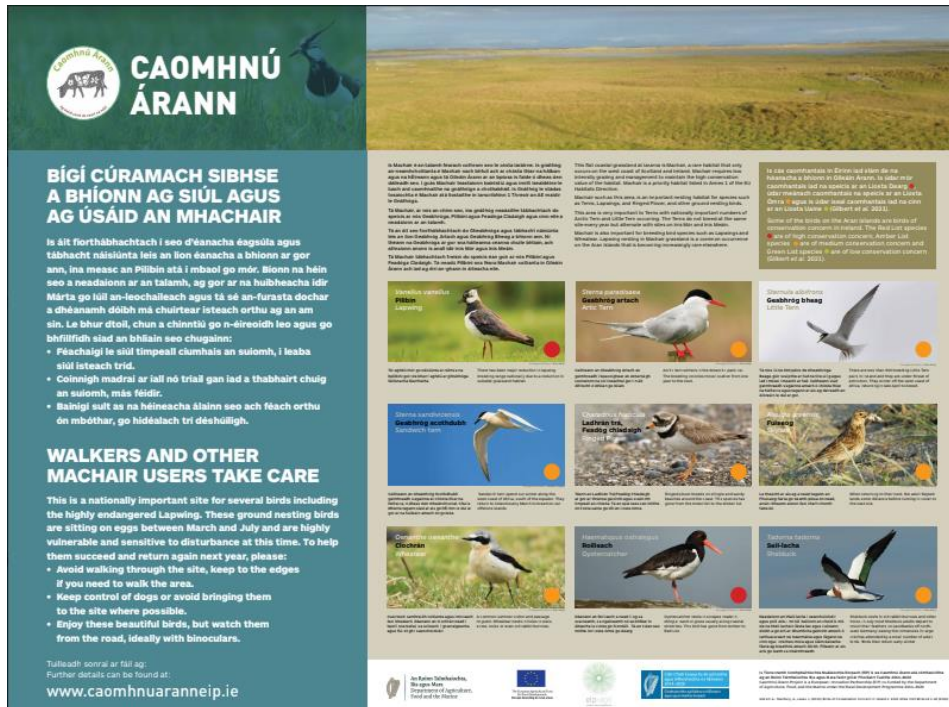
Fig.21 The information signs that are been used to raise awareness of the site and limit disturbance during the nesting season.

To aid management and inform the public, notice boards were placed around the site during the lapwing breeding site. This was initiated by the farmers as there were concerns regarding a high number of people exercising on the site with unleashed dogs. These notice boards will be maintained by the farmers and the Acres BurrenAran Co-operation team. Details of the notice boards are detailed in Figure 21. The co-operation team are looking at ways of continue to raise awareness of the importance of the site and have spoken to some of the tour guides on the island as this further raises awareness on the importance of the site.
